UNDERWATER BRIDGE INSPECTION REPORT

STRUCTURE NO. 55031

SOUTH BRANCH MIDDLE FORK ZUMBRO RIVER

DISTRICT 6 – OLMSTEAD COUNTY

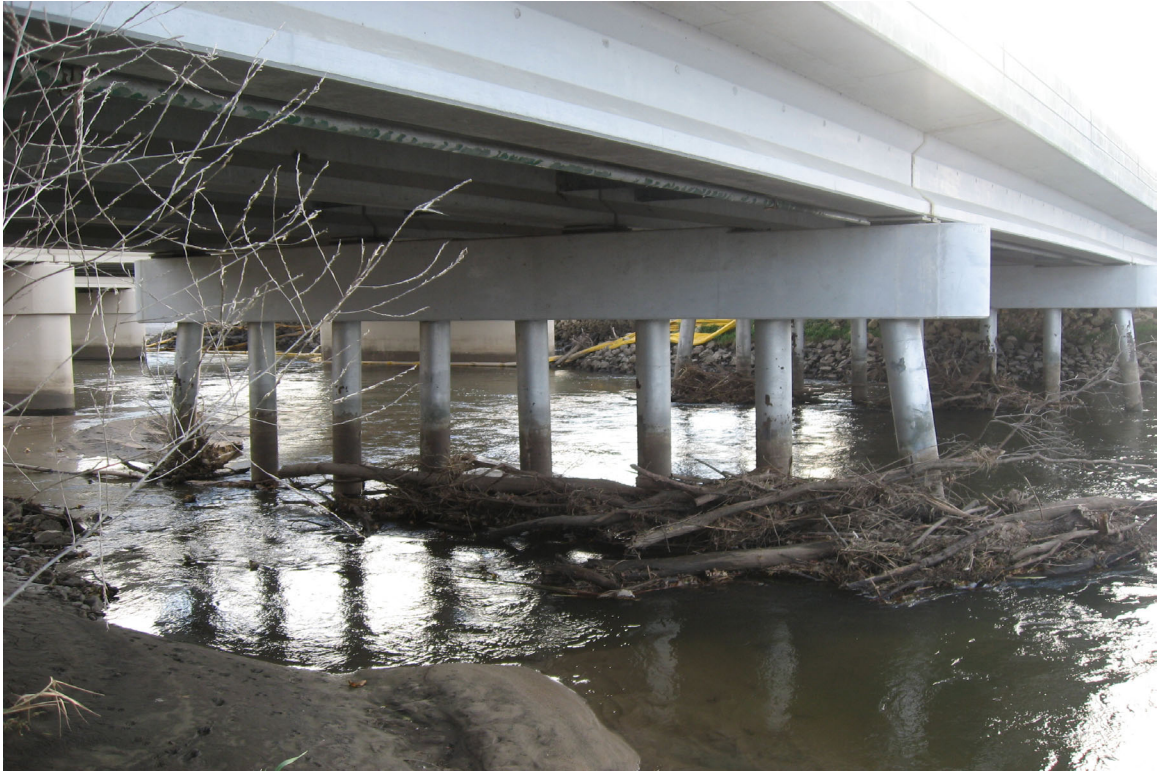
Photograph 1. View of the North Pier 1, Looking Southeast.

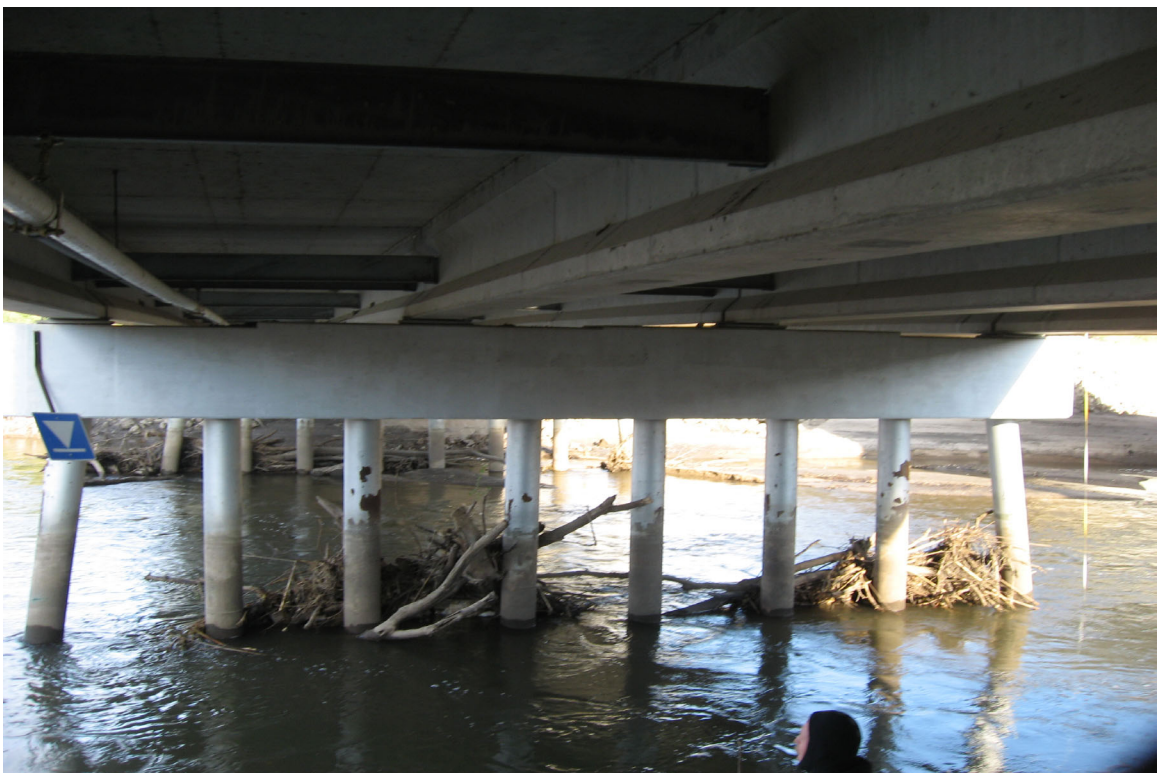
Photograph 2. View of the South Pier, Looking North.

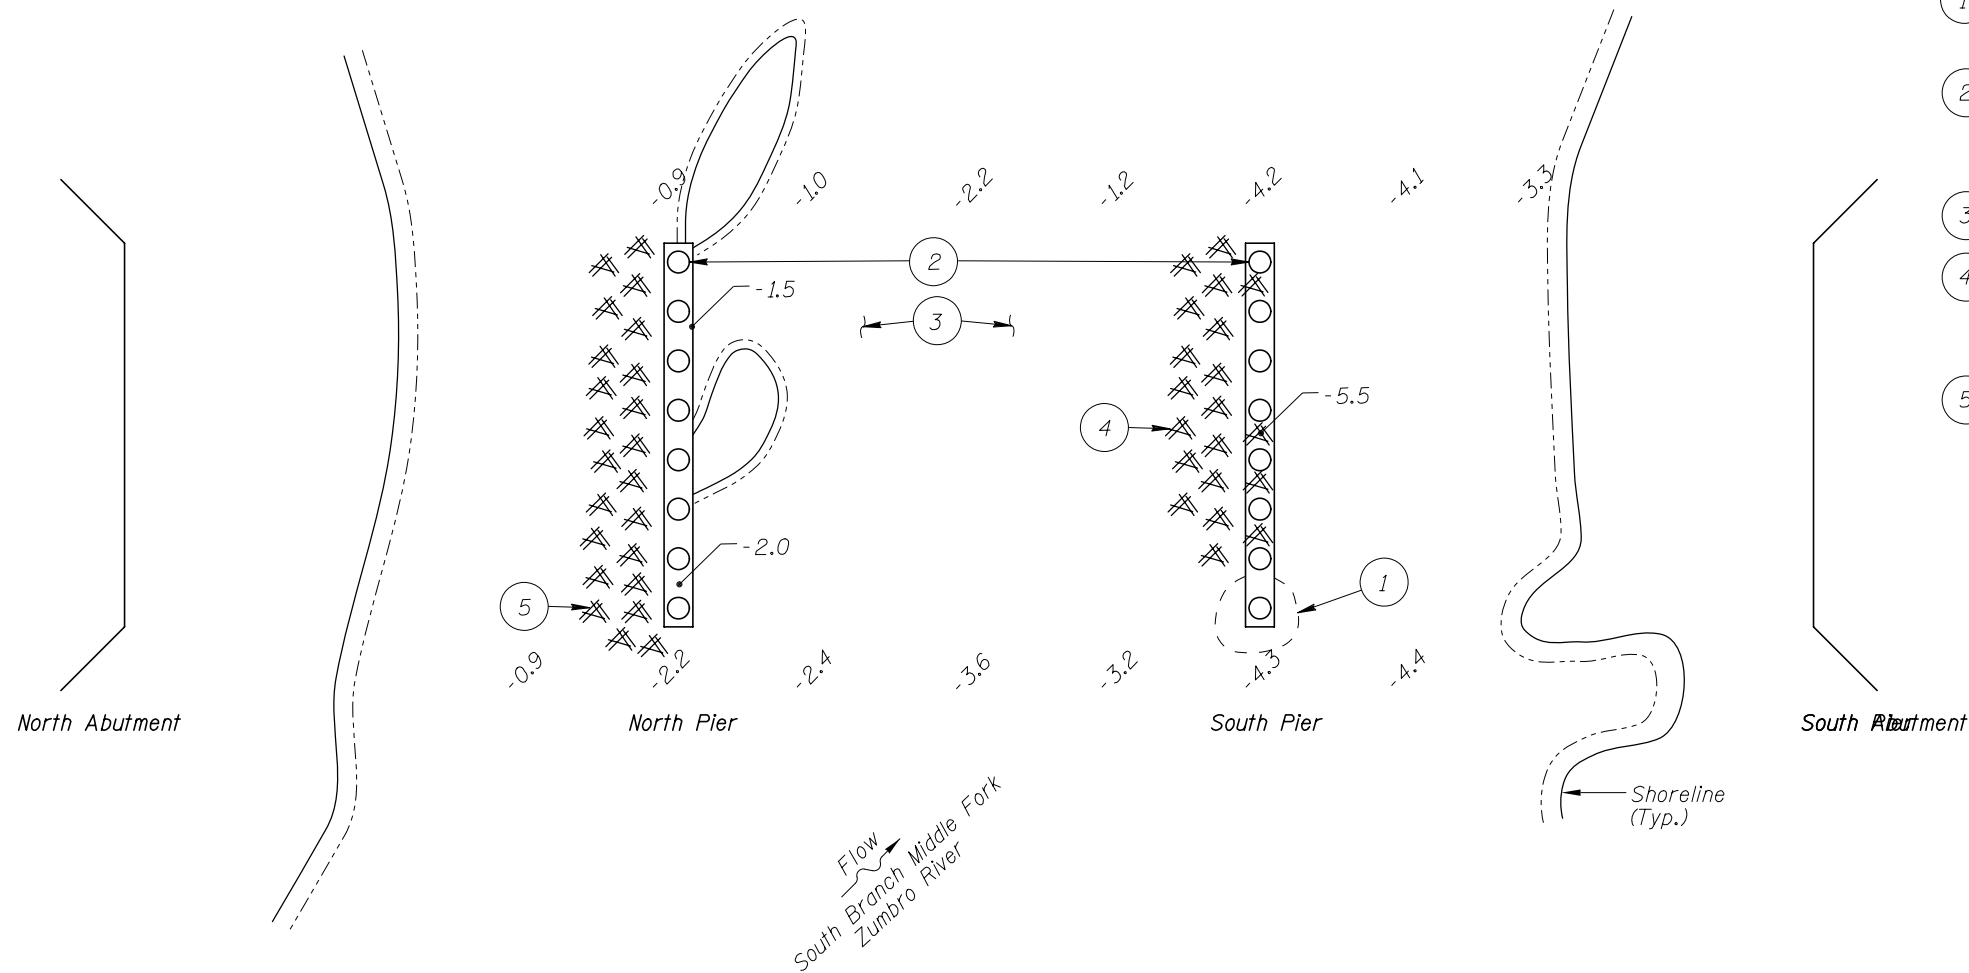
INSPECTION AND SOUNDING PLAN

- 1 A scour depression measuring 4 feet radially by 2 feet deep was observed at the upstream pile of the south pier.
- 2 Steel piles at both piers show no coating failure or corrosion below water; however, from the pile cap down 5 feet, there was up to 25 percent coating failure and minor surface corrosion.
- 3 The channel bottom consisted of silty sand with 1 foot maximum probe rod penetration.
- 4 A heavy accumulation of timber debris consisting of 1.5 feet diameter and smaller logs and branches was observed at the north side of the south pier extending from the channel bottom to 5 feet above the waterline.
- 5 A heavy accumulation of timber debris consisting of 2 feet diameter and smaller logs and branches was observed at the north side of the north pier extending from the channel bottom to 5 feet above the waterline.
